TECHNICAL REPORT CERC-85-10

# WAVE STABILITY TESTS OF DOLOS AND STONE REHABILITATION DESIGNS FOR THE EAST BREAKWATER, CLEVELAND HARBOR, OHIO

Experimental Model Investigation

Coastal Engineering Research Center

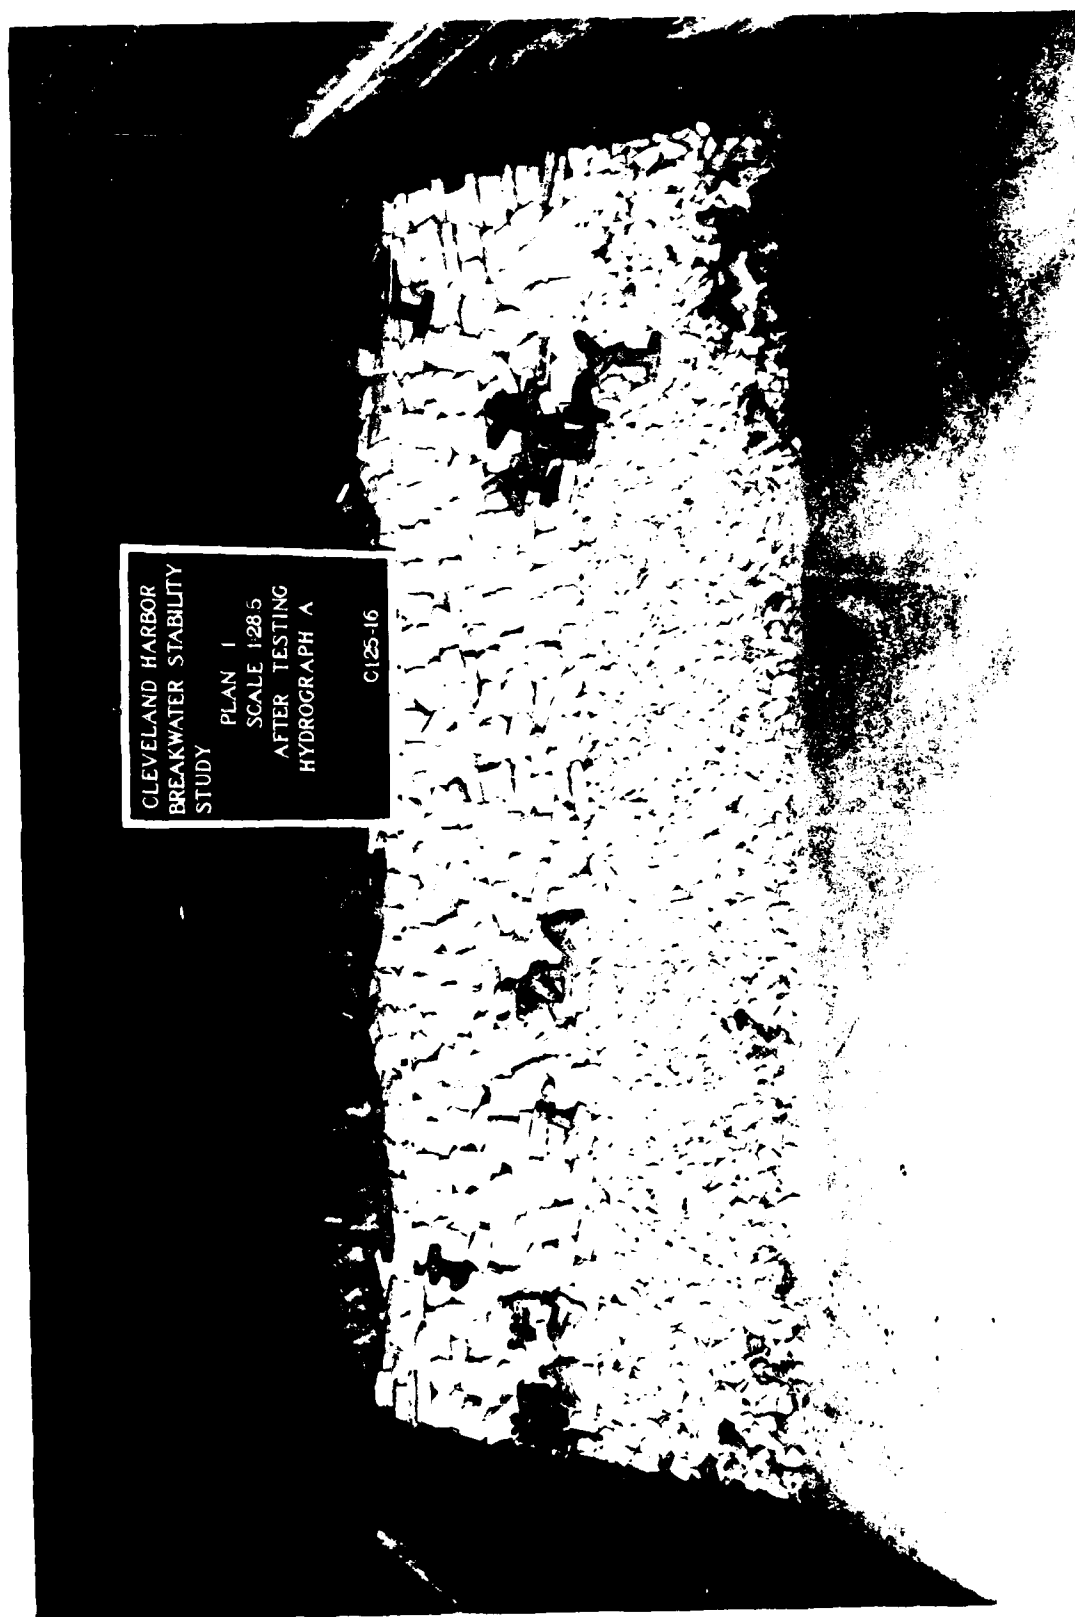
Photo 15. Harbor-side view of Plan 1 after testing Hydrograph A, second test section

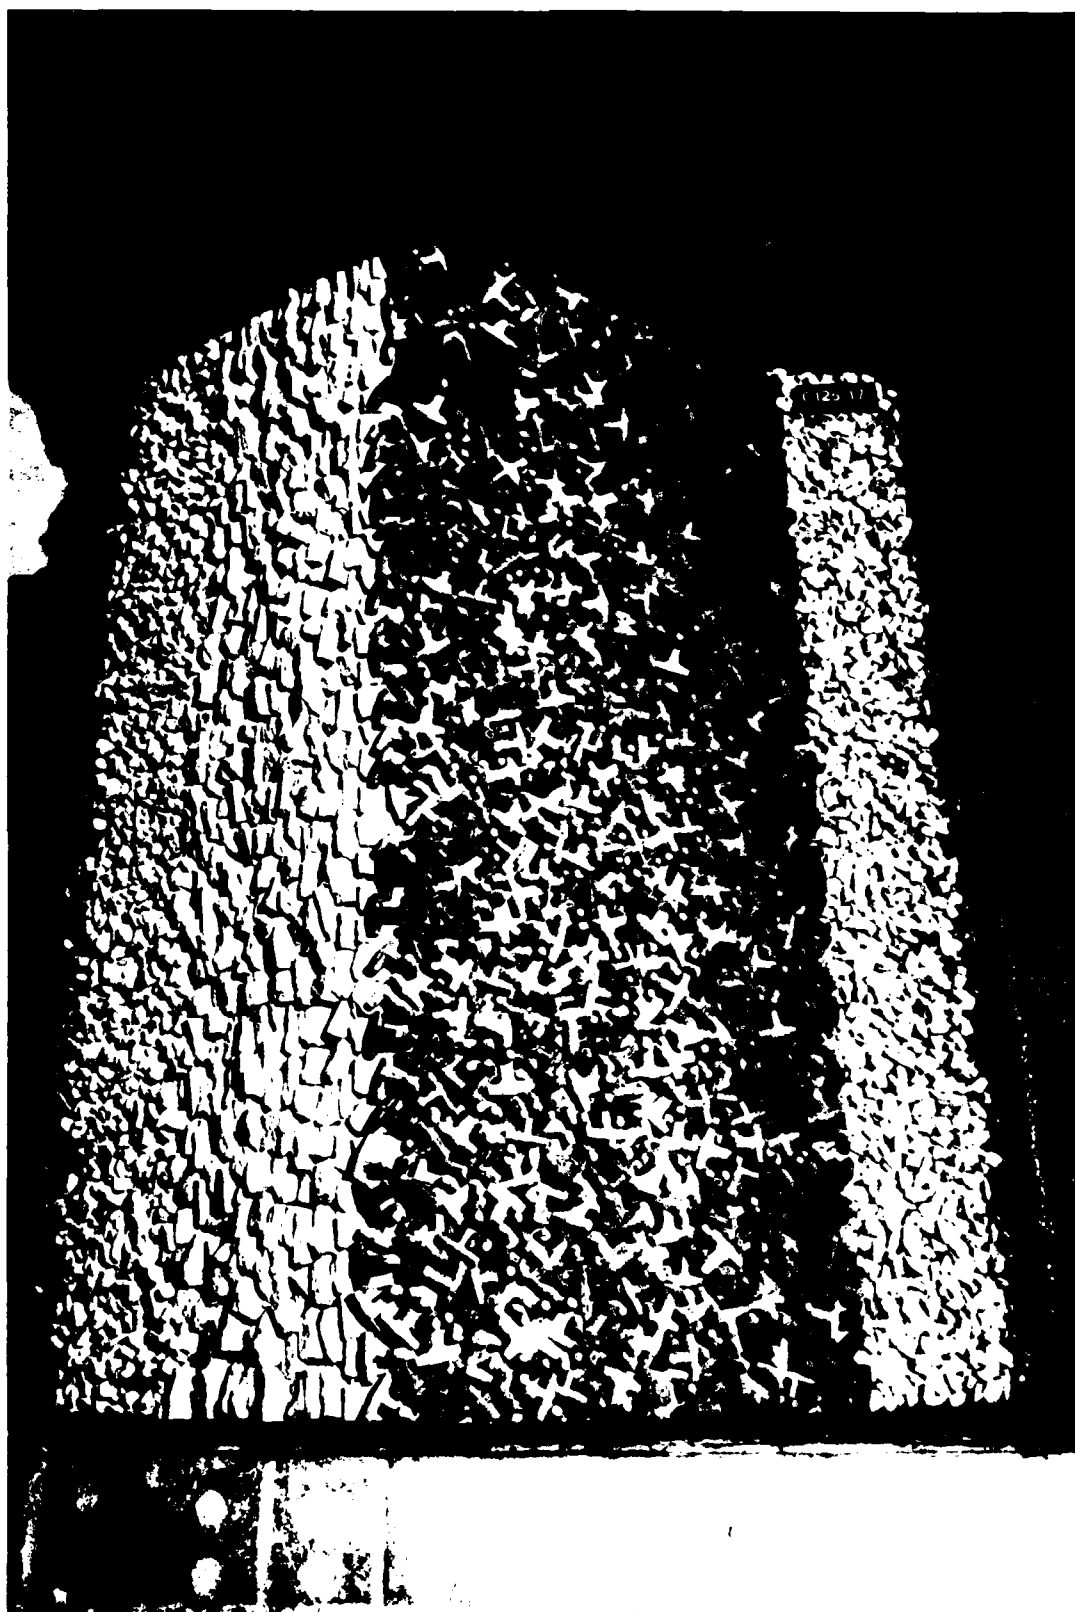
Photo 16. Overhead view of Plan 1 before testing,  
third test section

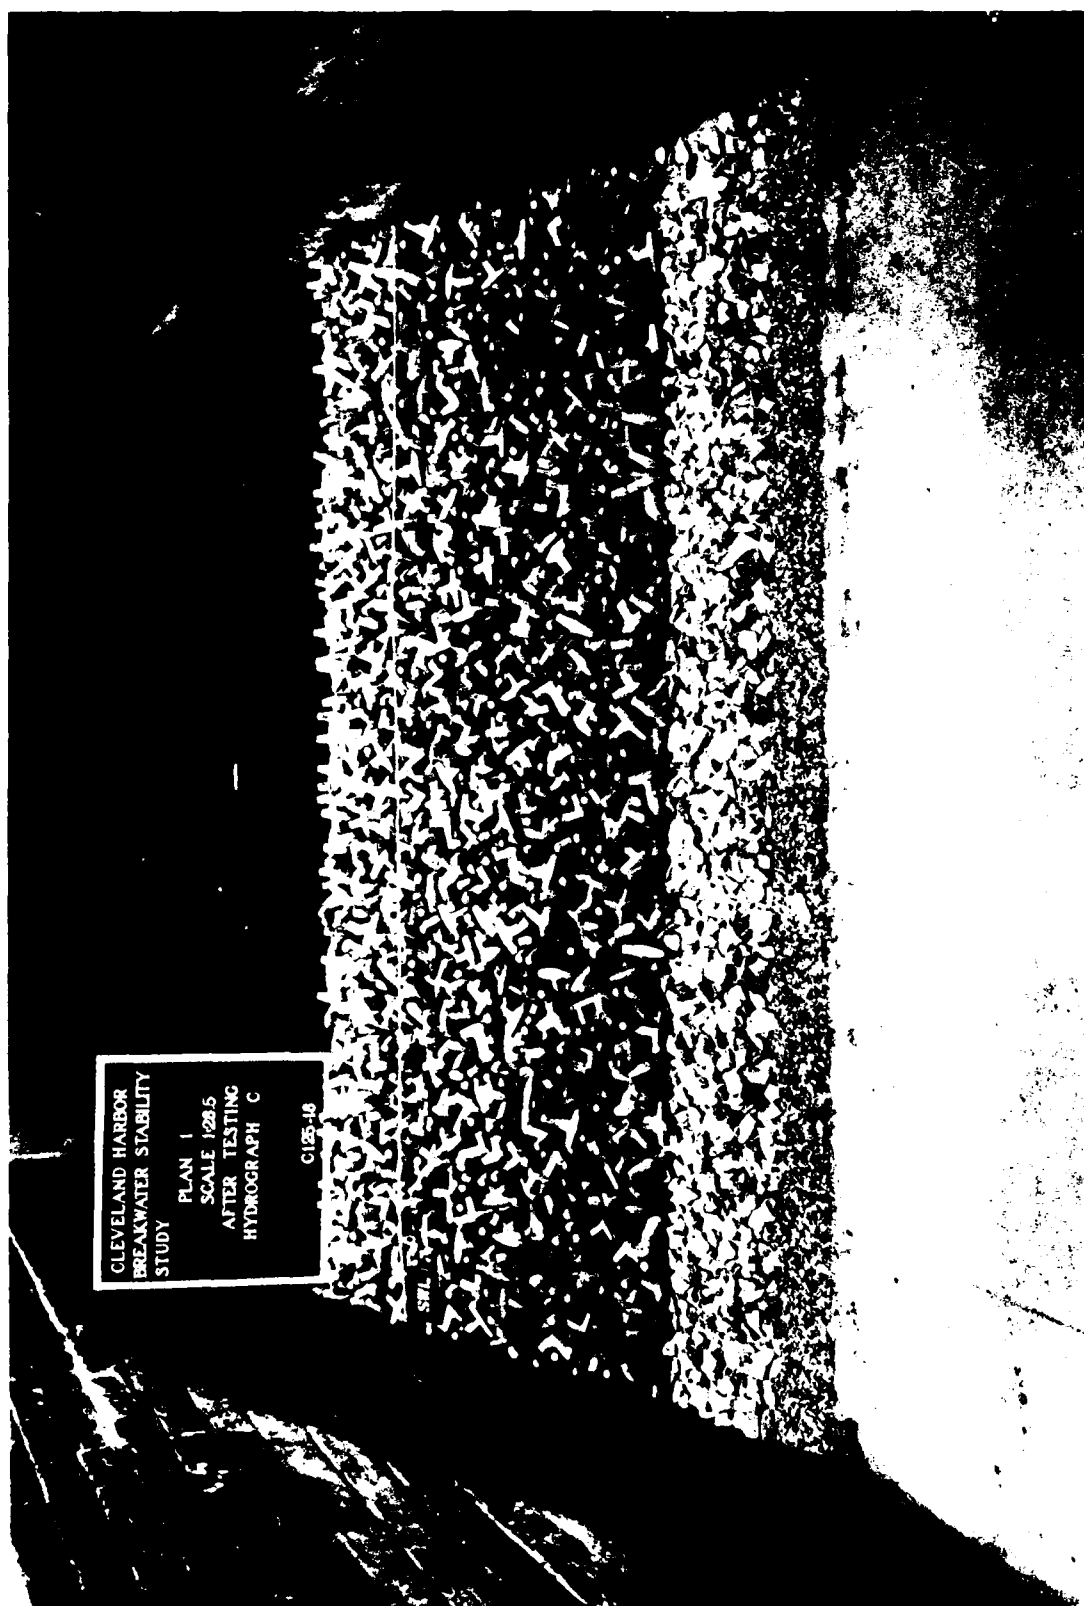
Photo 17. Lakeside view of Plan 1 after testing Hydrograph C, third test section

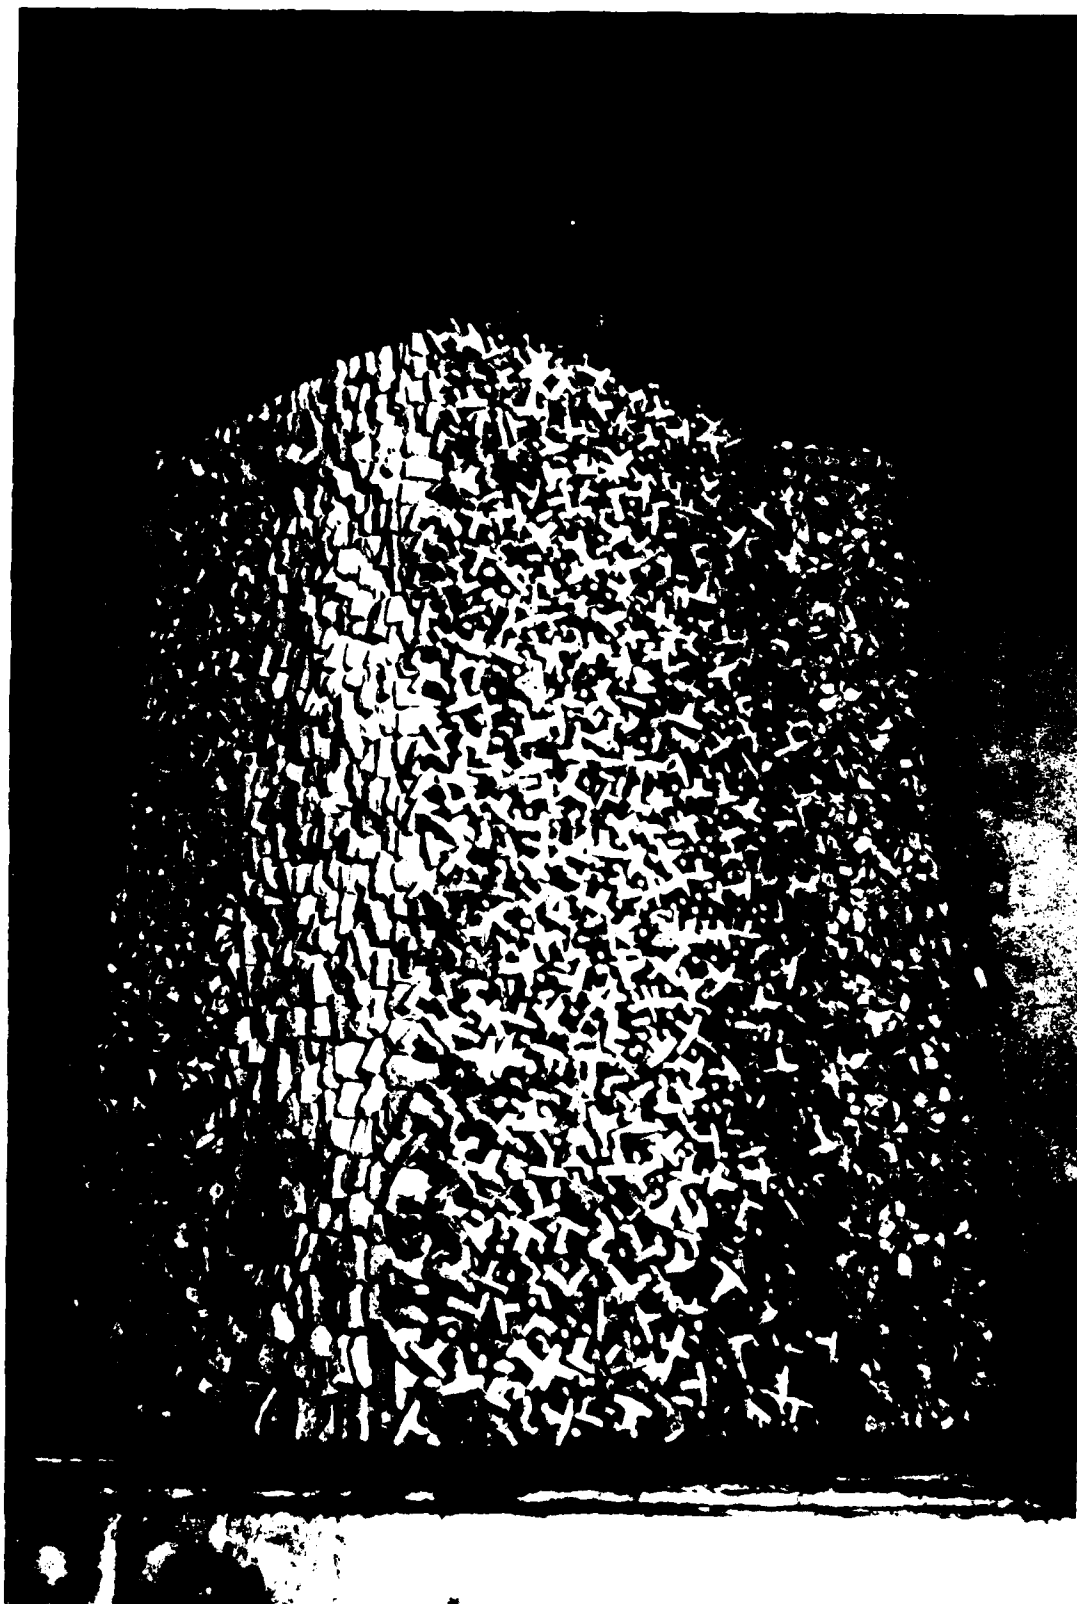
Photo 18. Overhead view of Plan 1 after testing Hydrograph C,  
third test section

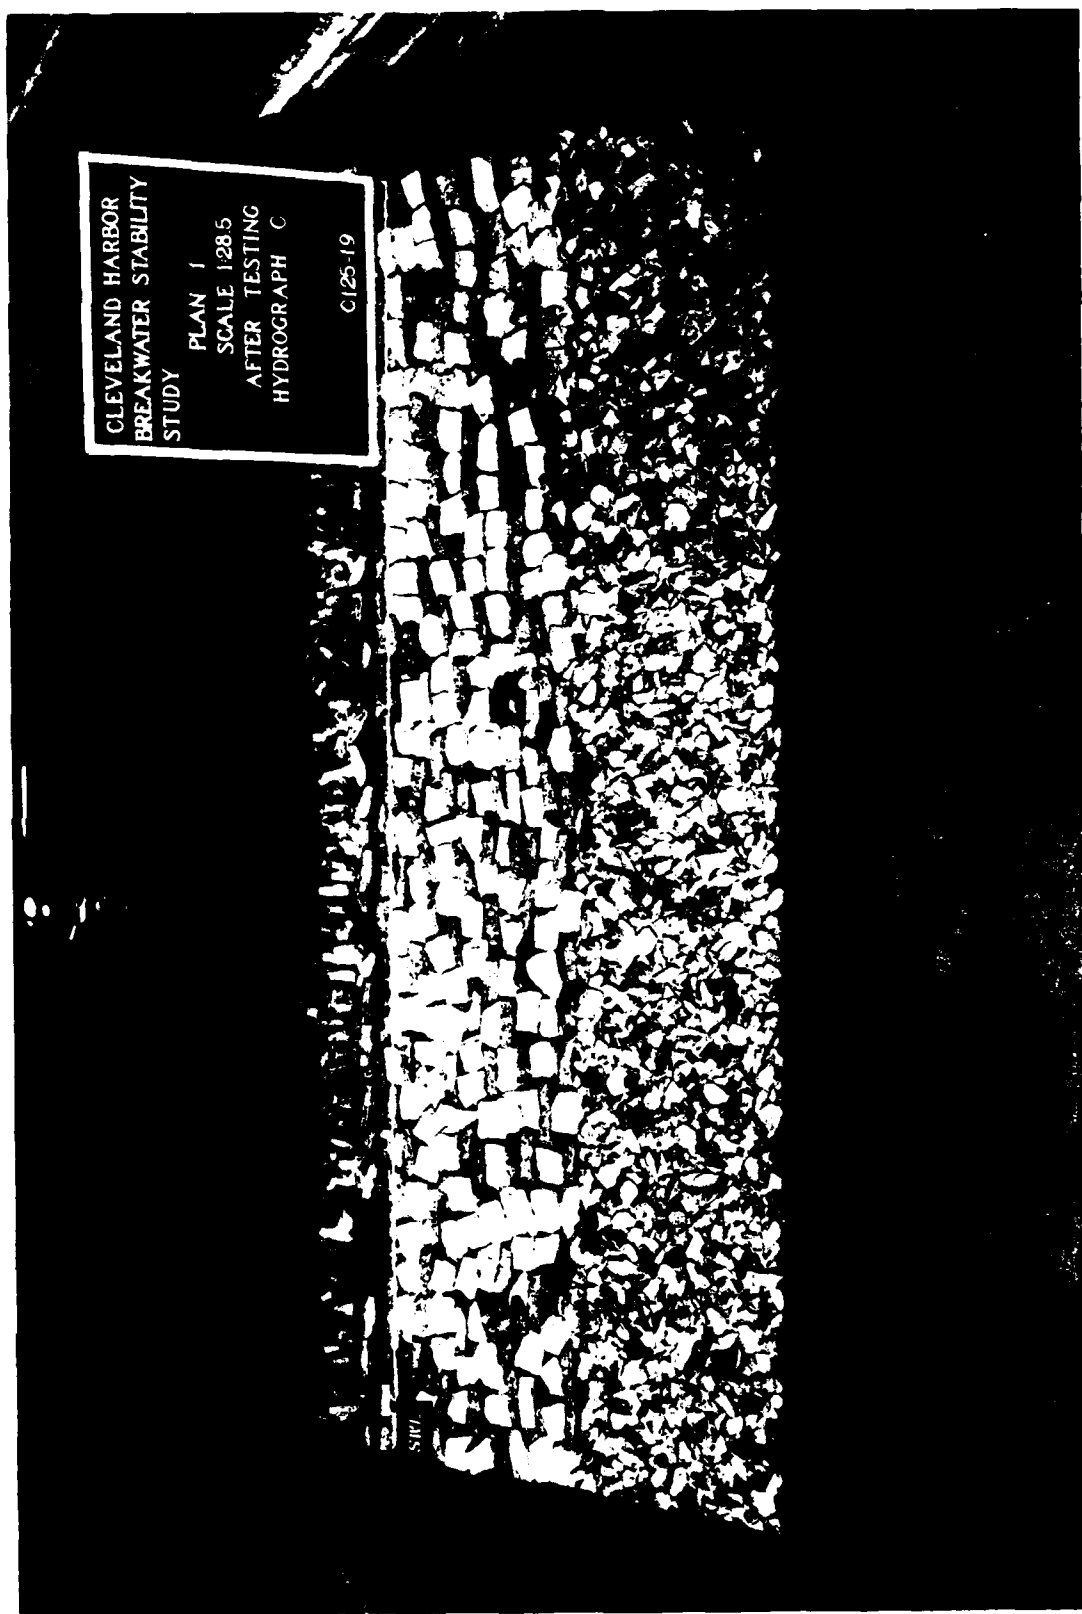
Photo 19. Harbor-side view of Plan 1 after testing Hydrograph C, third test section

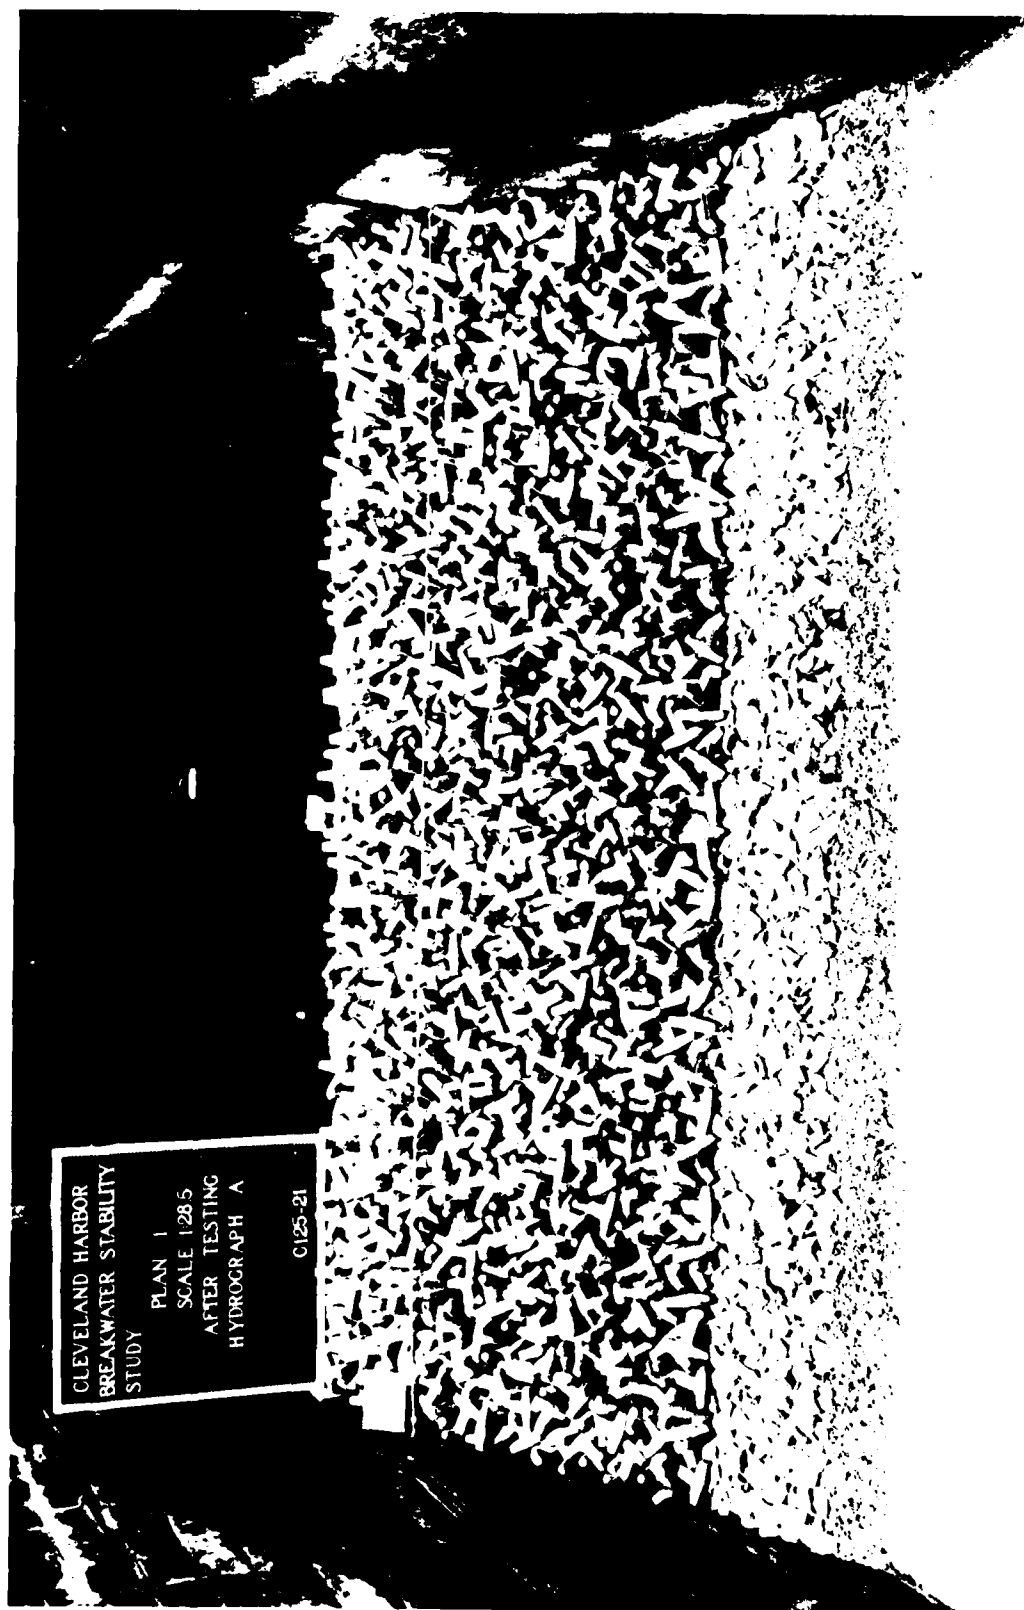
Photo 20. Lakeside view of Plan 1 after testing Hydrographs C and A, third test section

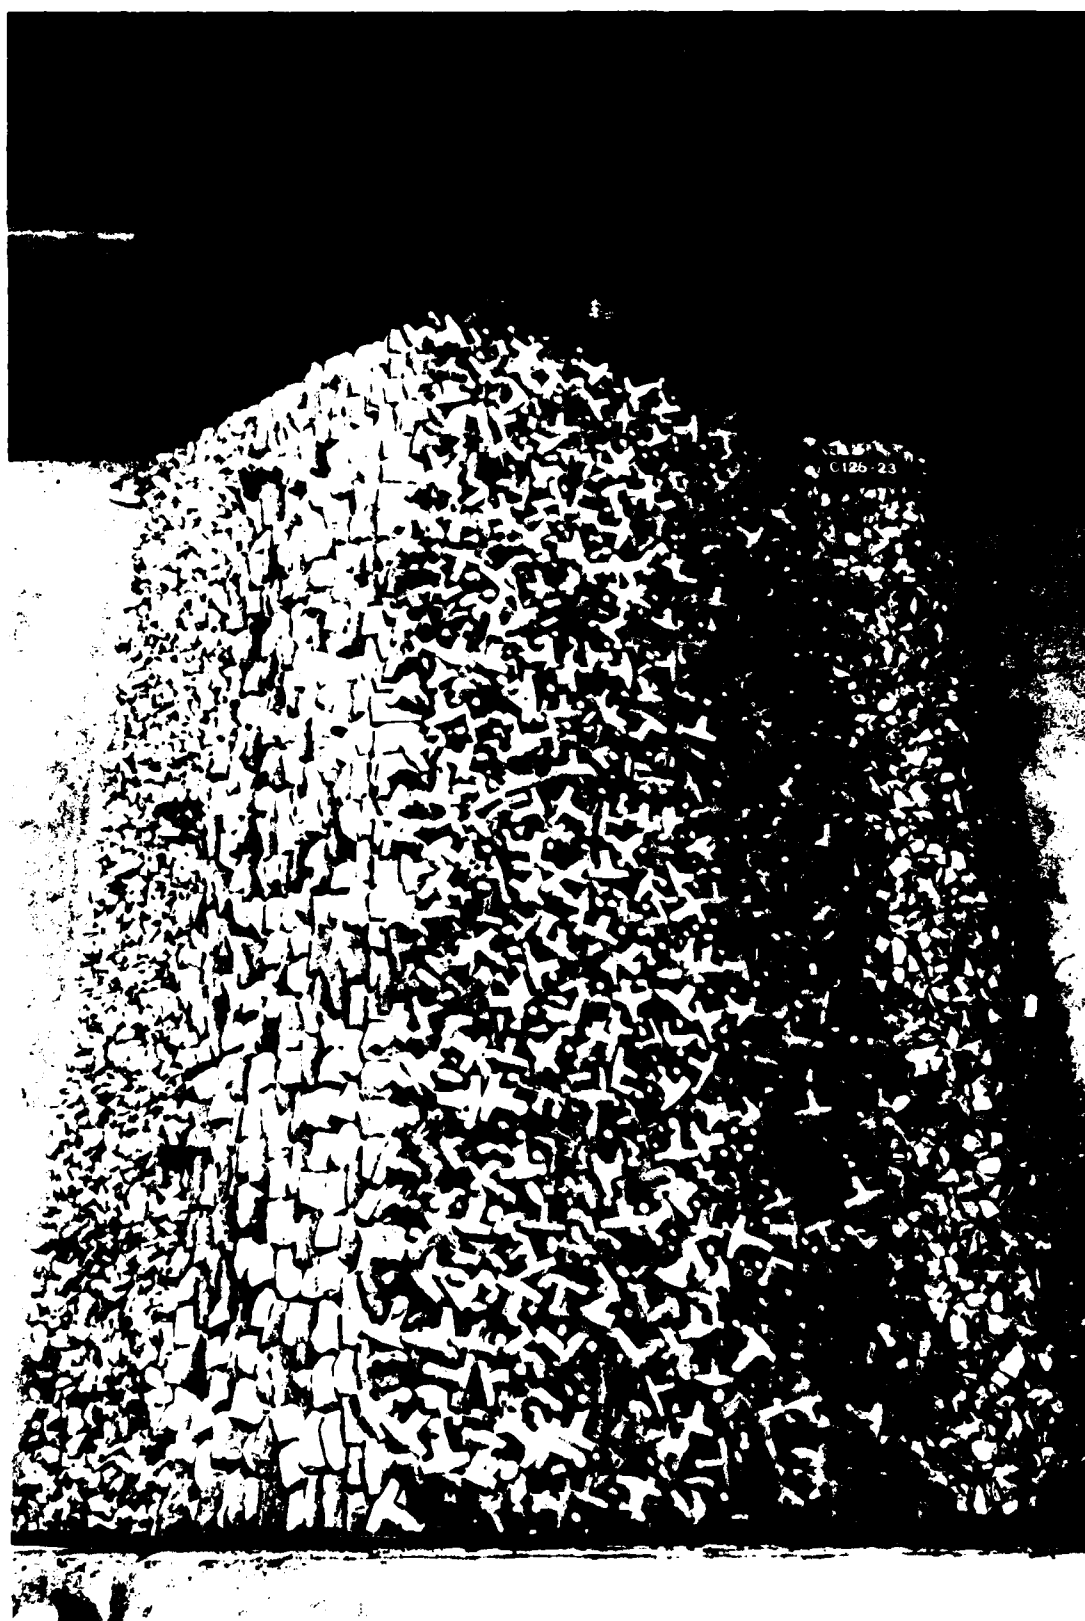
Photo 21. Overhead view of Plan 1 after testing Hydrographs C and A, third test section

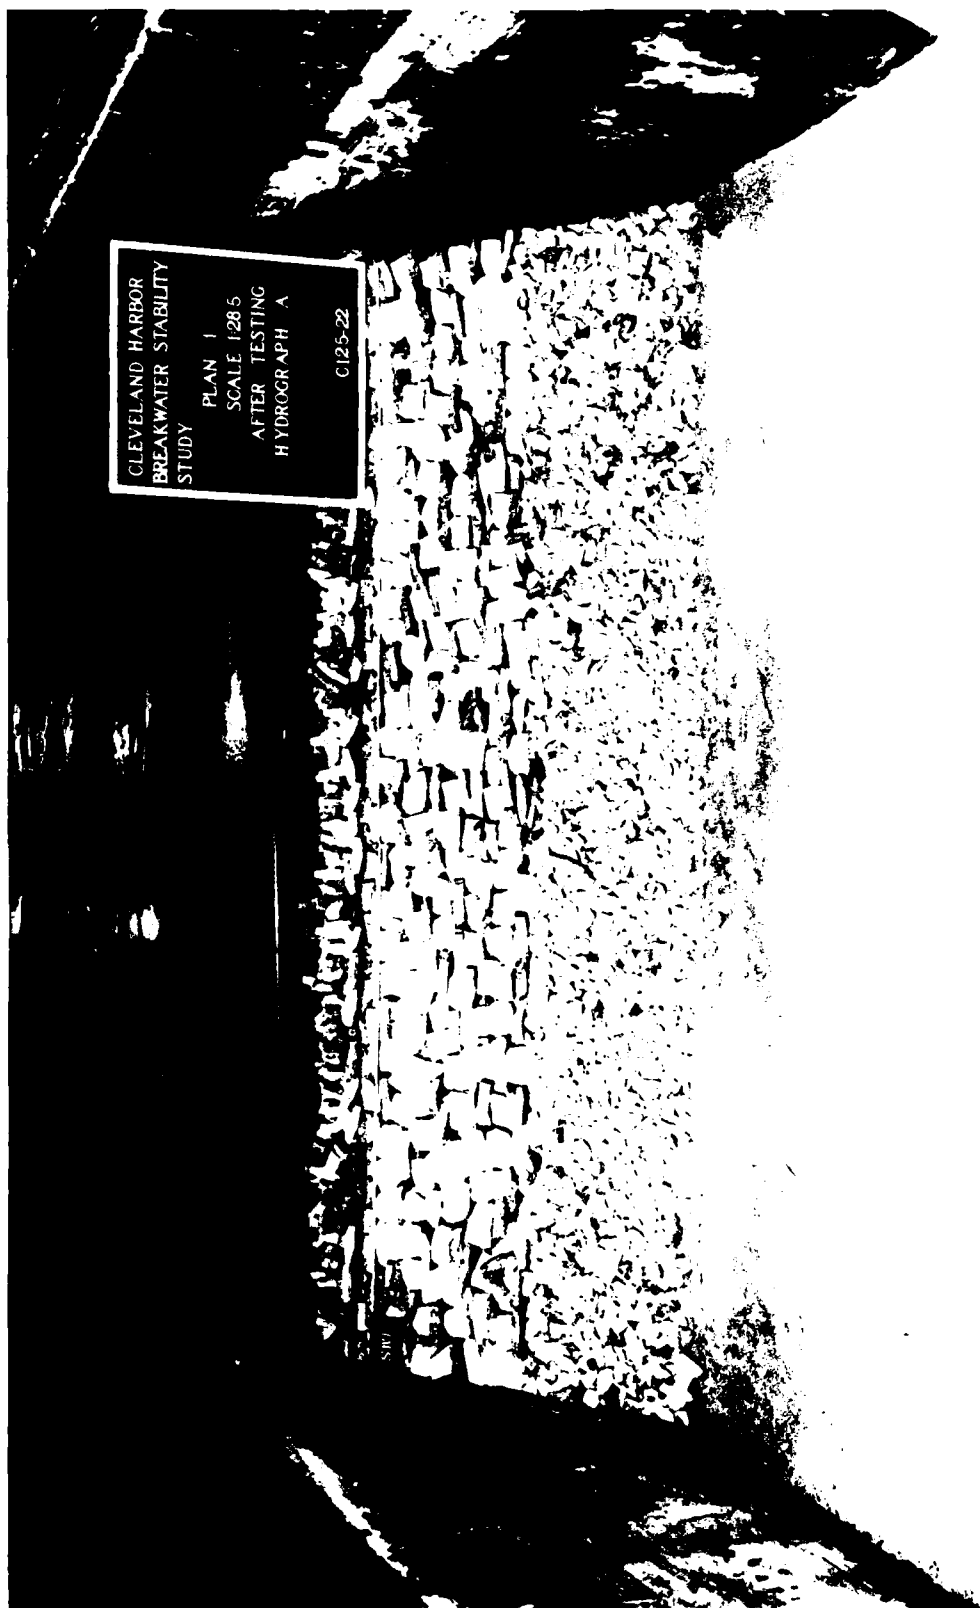
Photo 22. Harbor-side view of Plan 1 after testing Hydrographs C and A, third test section

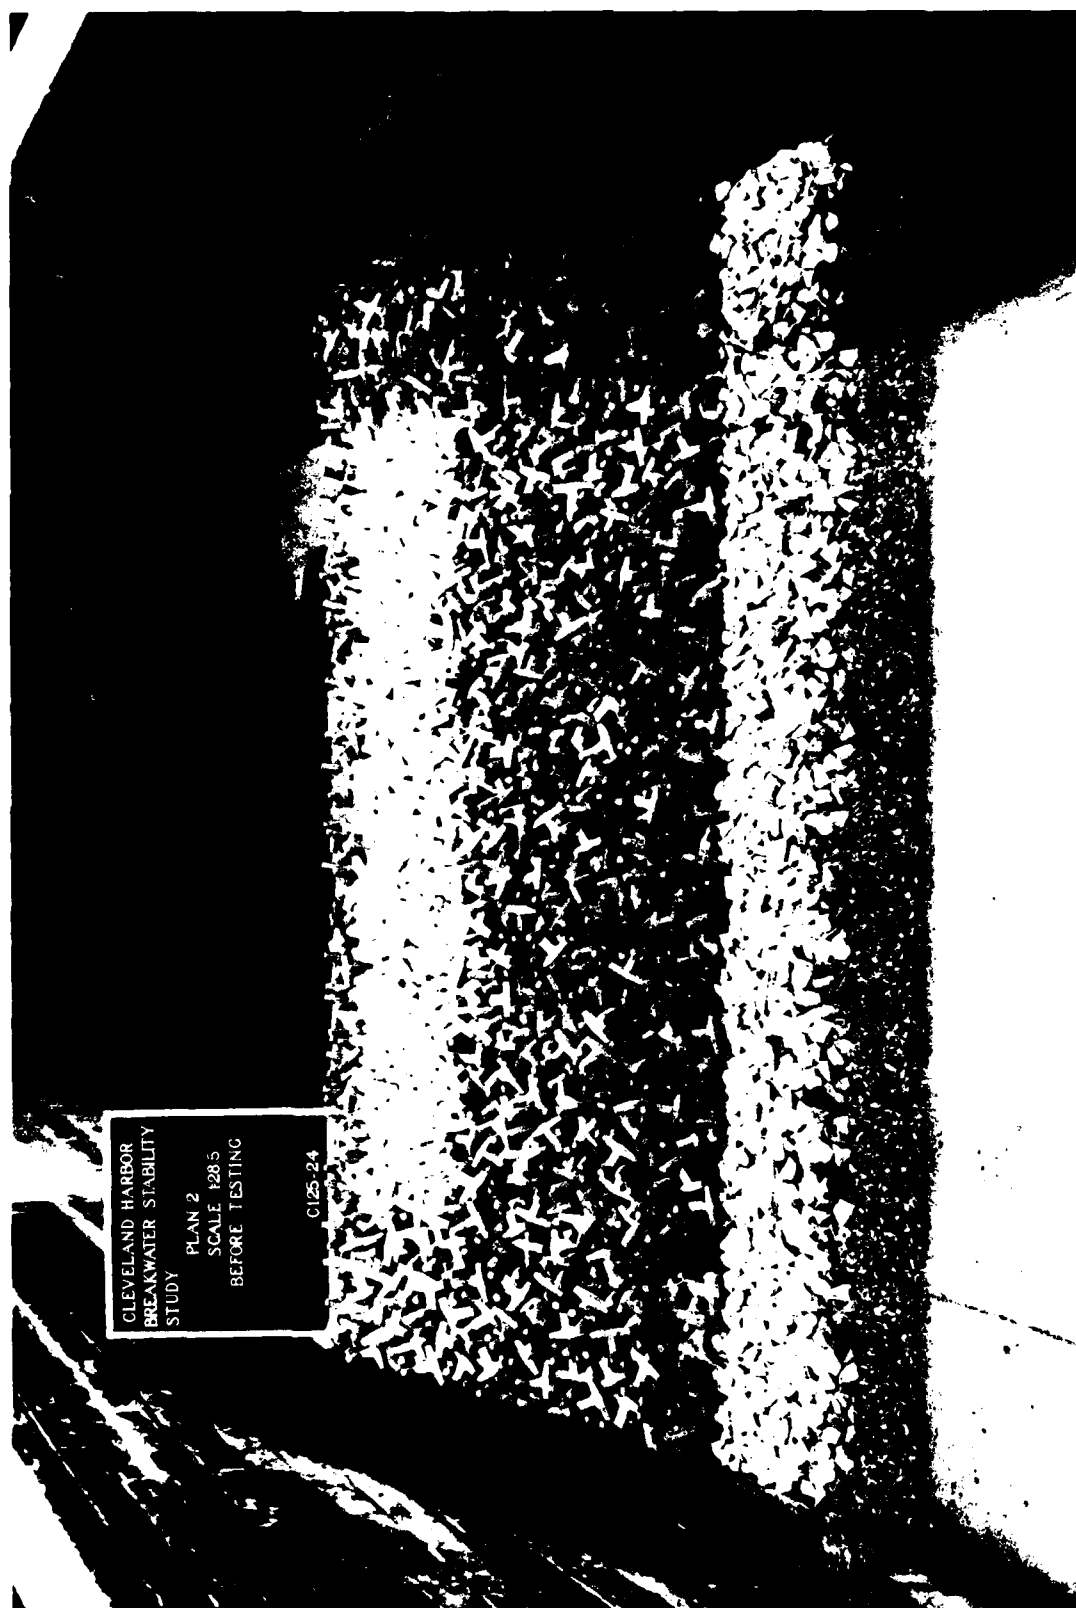
Photo 23. Lakeside view of Plan 2 before testing, first test section

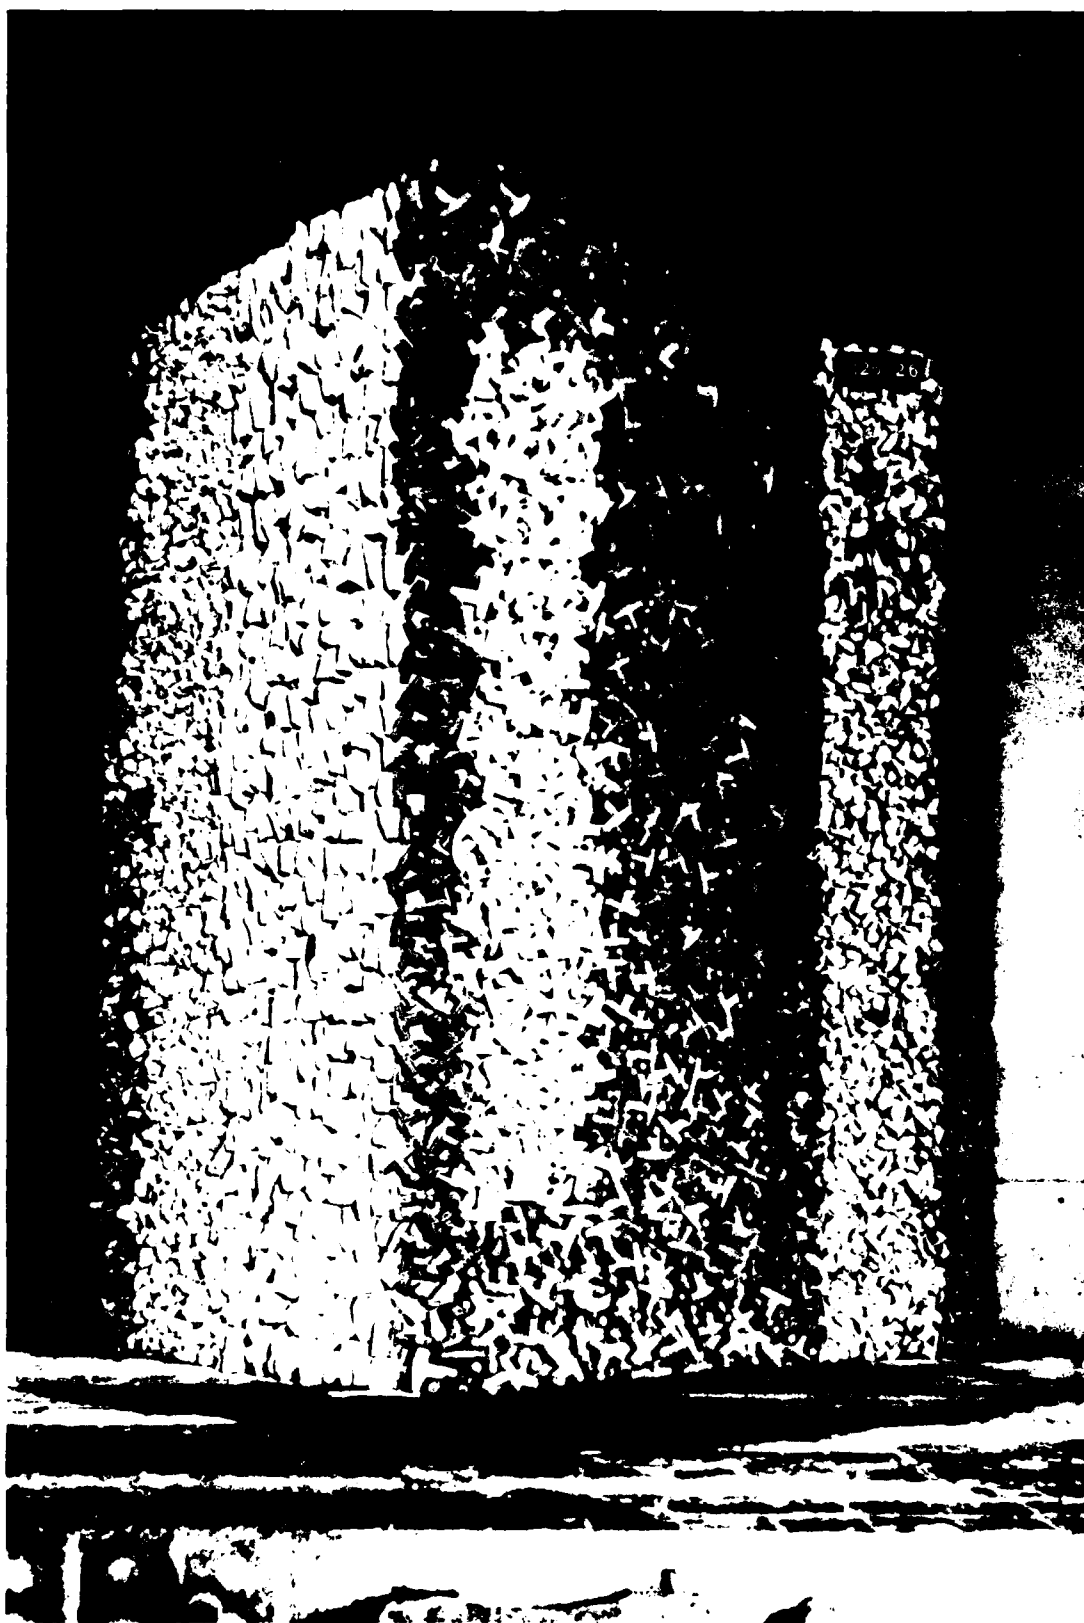
Photo 24. Overhead view of Plan 2 before testing,  
first test section

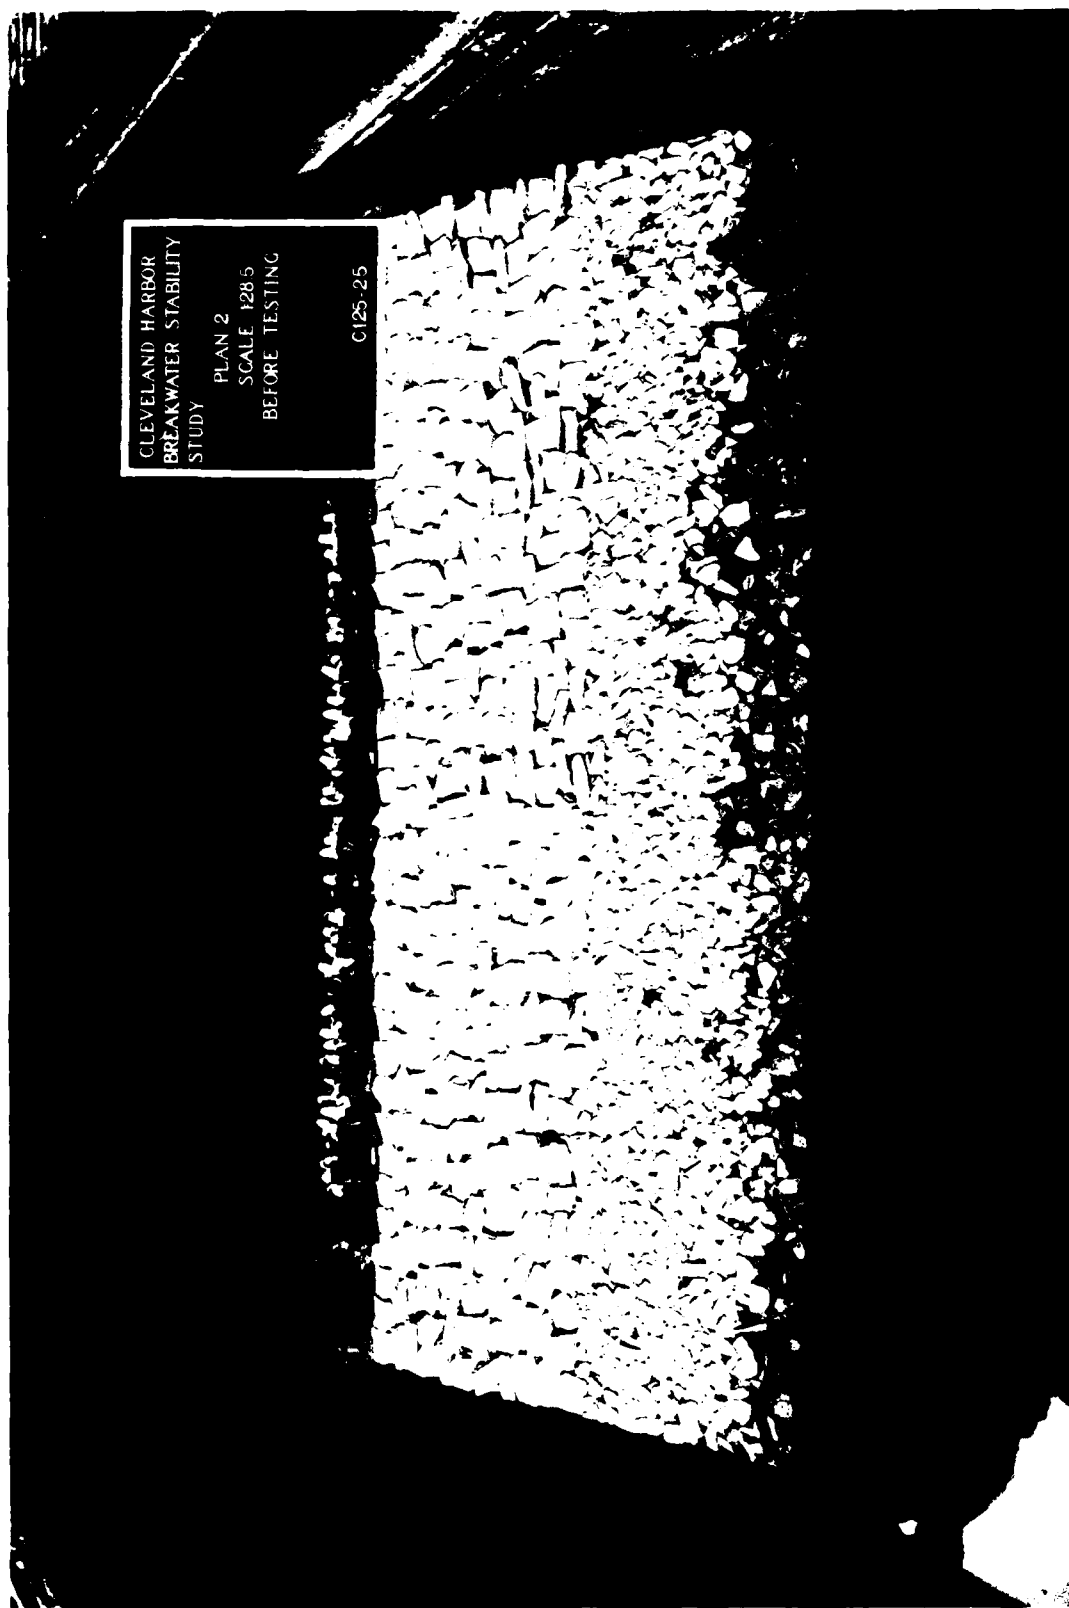
Photo 25. Harbor-side view of Plan 2 before testing, first test section

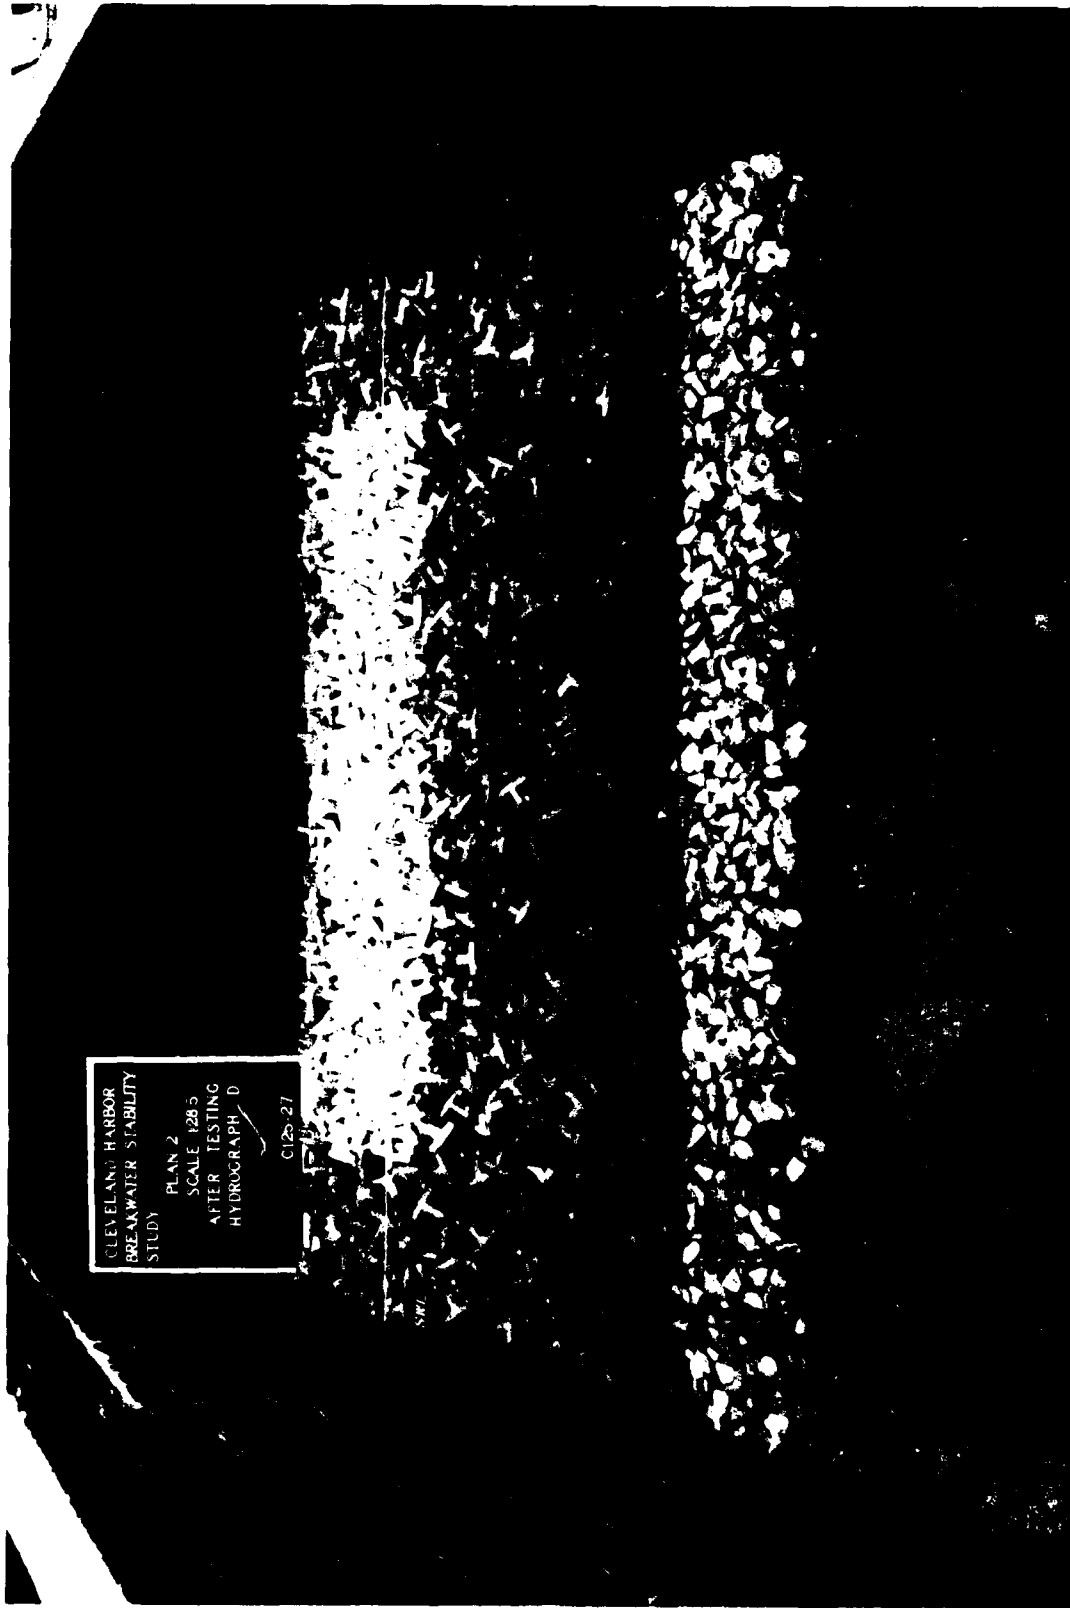
Photo 26. Lakeside view of Plan 2 after testing Hydrograph D, first test section

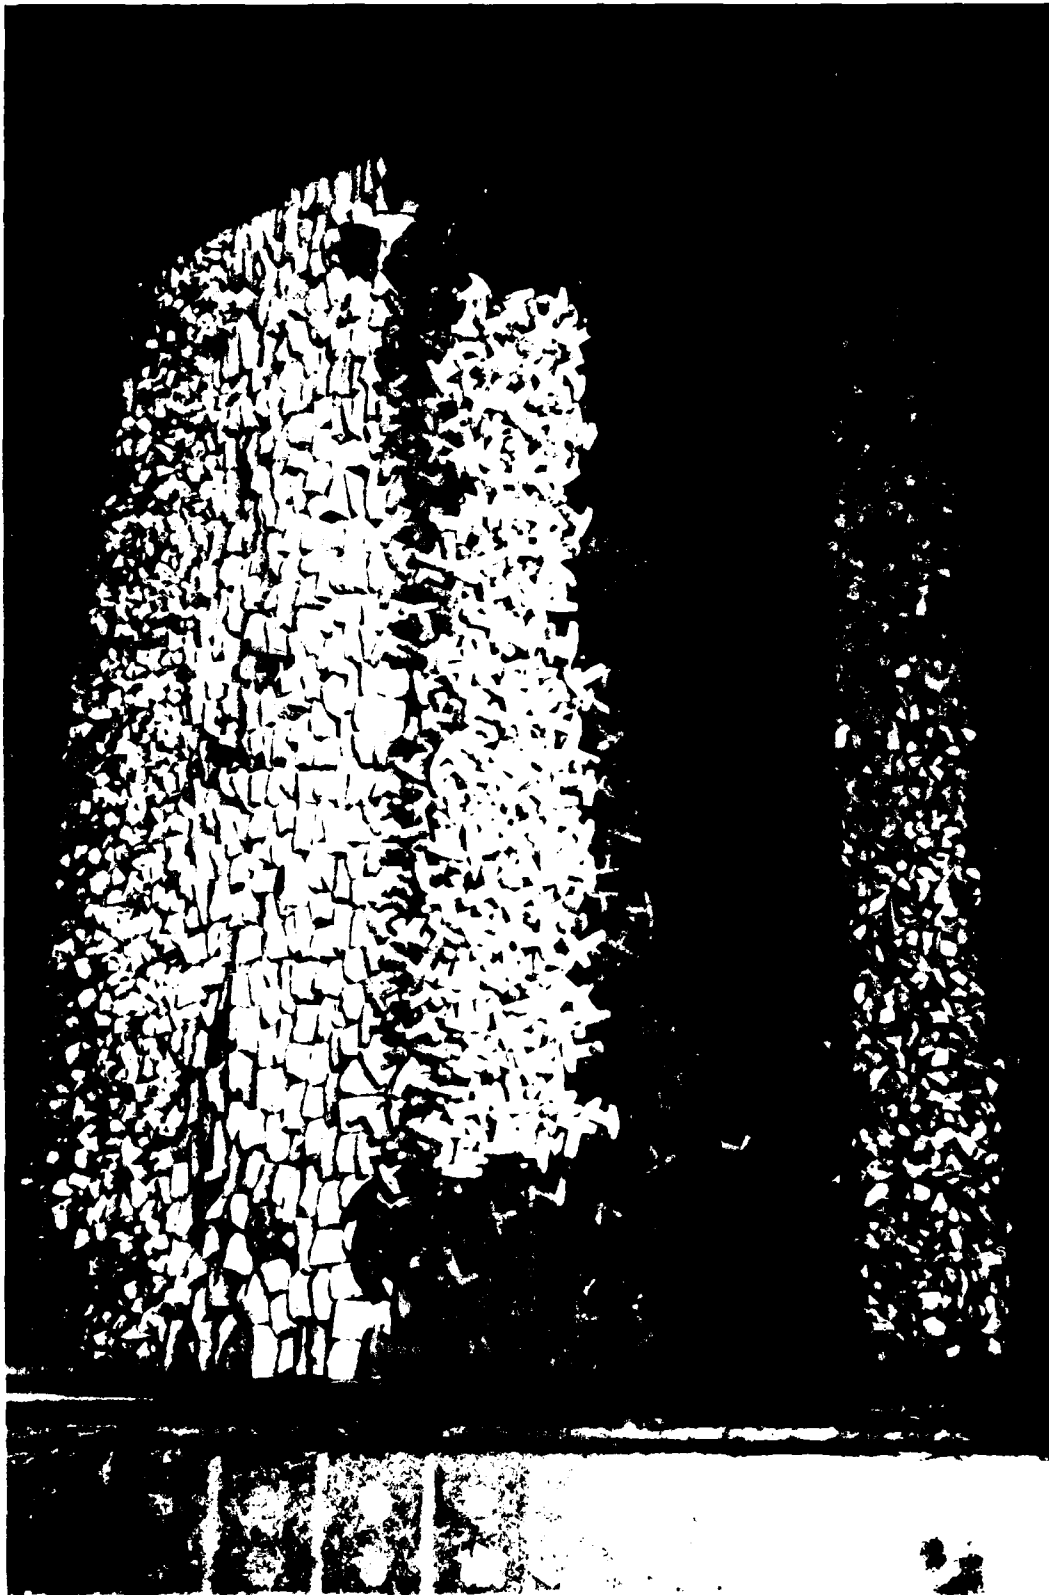
Photo 27. Overhead view of Plan 2 after testing Hydrograph D,  
first test section
